# dsPIC33FJ06GS001/101A/102A/202A and dsPIC33FJ09GS302

## dsPIC33FJ06GS001/101A/102A/202A and dsPIC33FJ09GS302 Family Silicon Errata and Data Sheet Clarification

The dsPIC33FJ06GS001/101A/102A/202A and dsPIC33FJ09GS302 family devices that you have received conform functionally to the current Device Data Sheet (DS75018C), except for the anomalies described in this document.

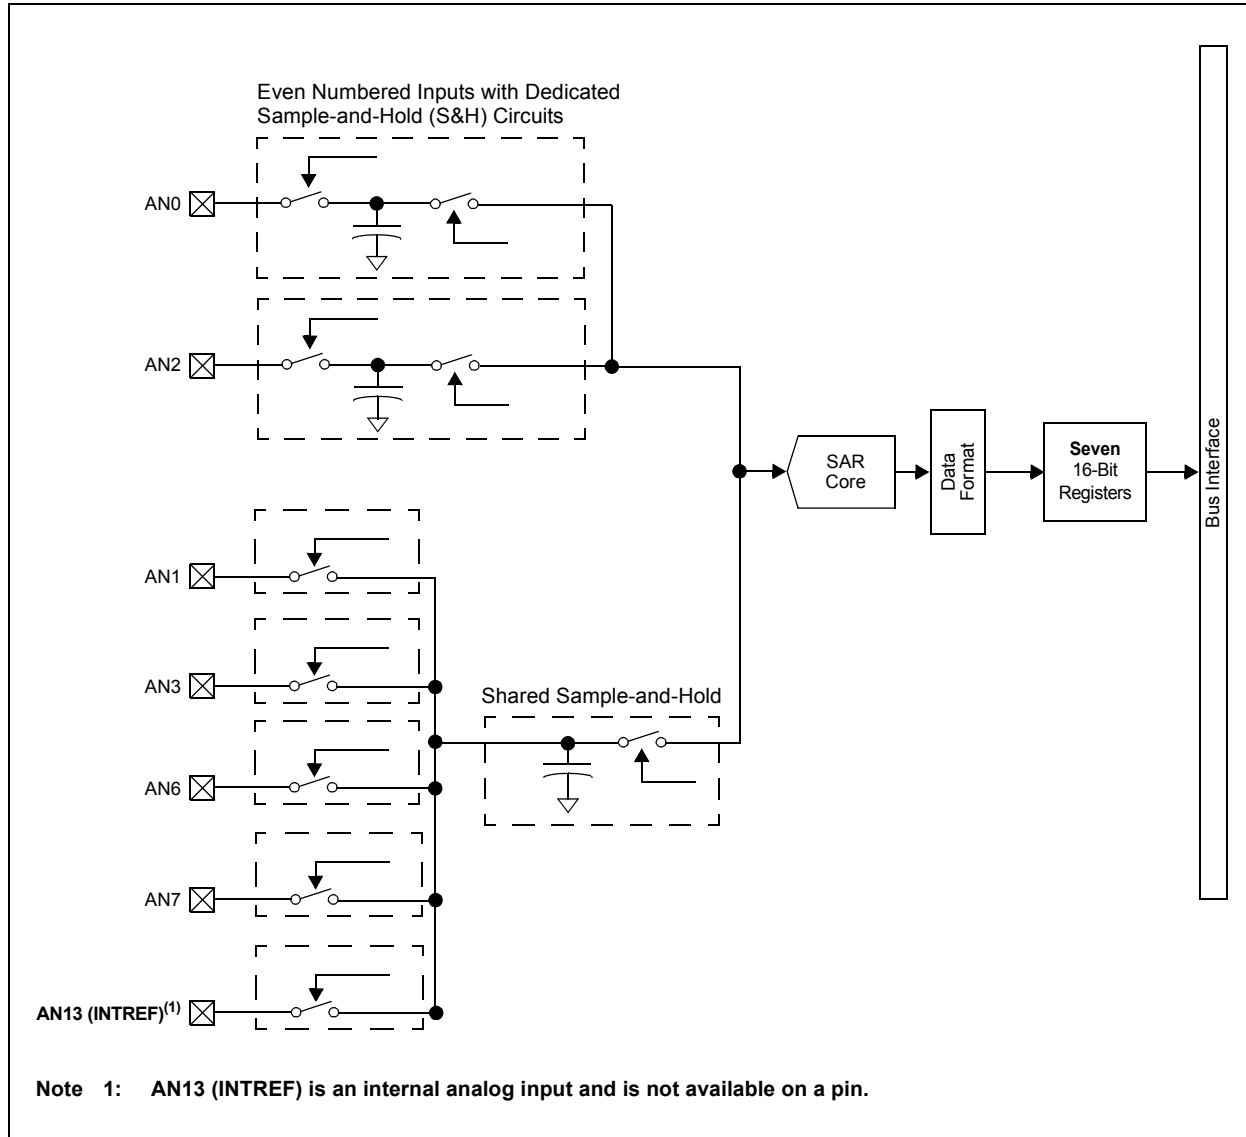
**FIGURE 19-2: ADC BLOCK DIAGRAM FOR THE dsPIC33FJ06GS101A DEVICE**

In Figure 19-2 and Figure 19-3, AN13 has been added and the number of output registers has been changed from eight to seven.

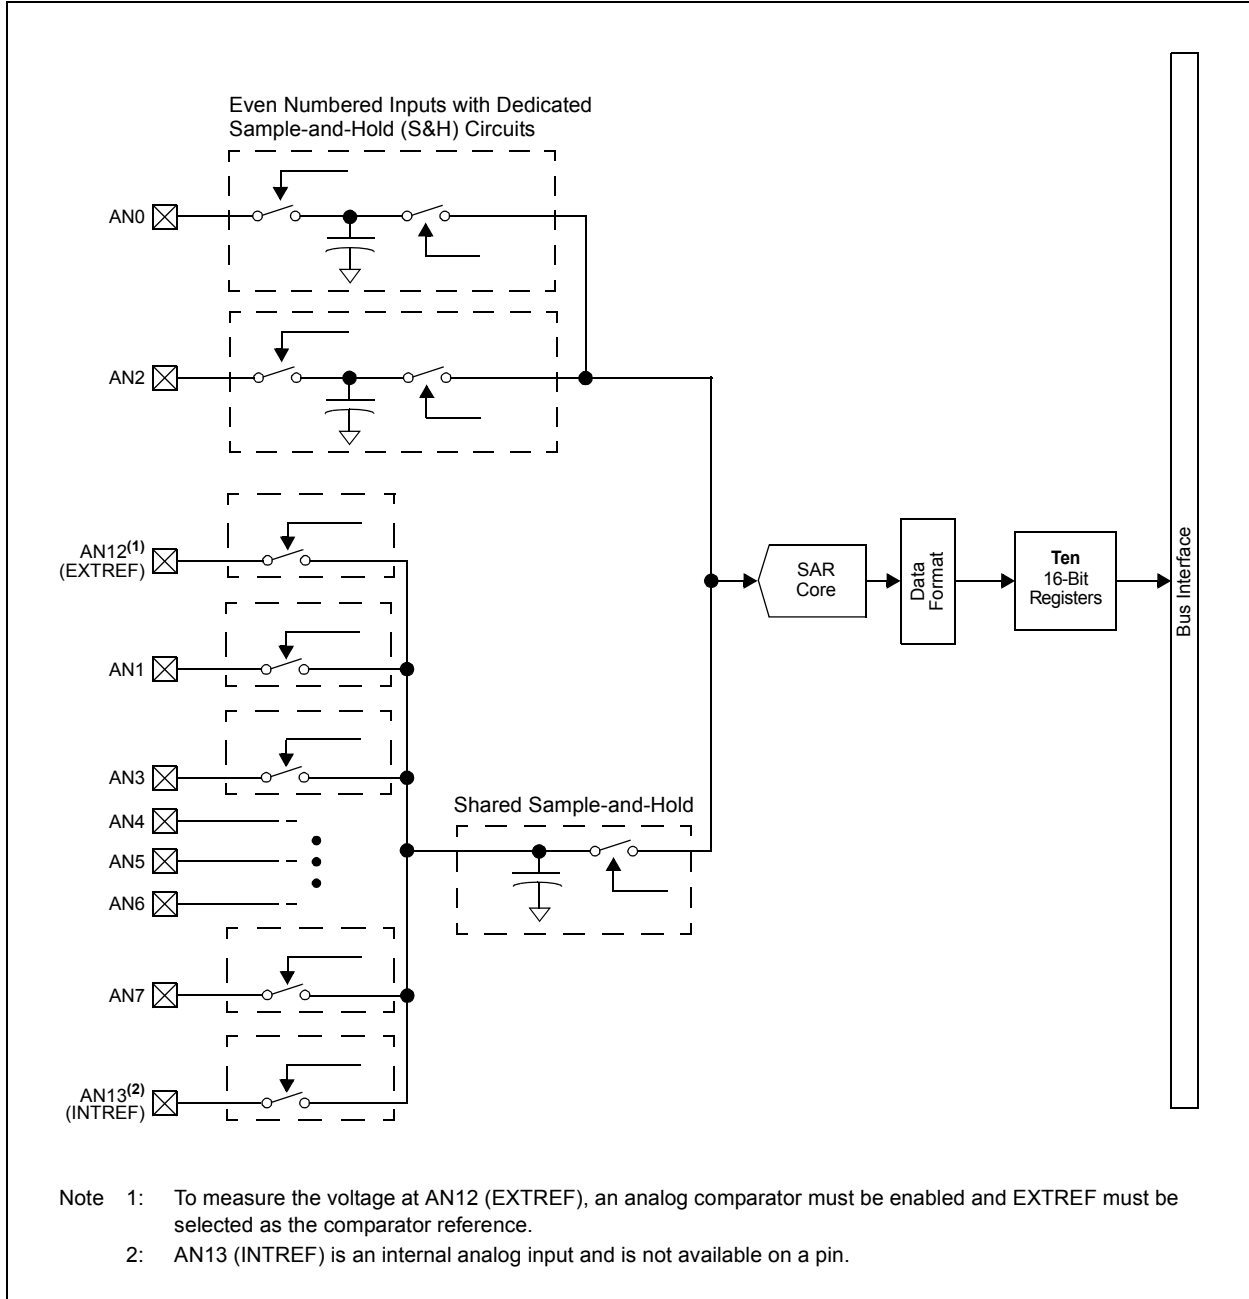
FIGURE 19-5: ADC BLOCK DIAGRAM FOR THE dsPIC33FJ09GS302 DEVICE

In Figure 19-5, the number of output registers has been changed from eight to ten. The changes are shown in bold below:
