Introduction

Thank you for designing with the Xilinx Defense-Grade Zynq®-7000Q family of devices. Although Xilinx has made every effort to ensure the highest possible quality, the devices listed in [Table 1](#) are subject to the limitations described in the following errata.

Processor System (PS) Errata Details

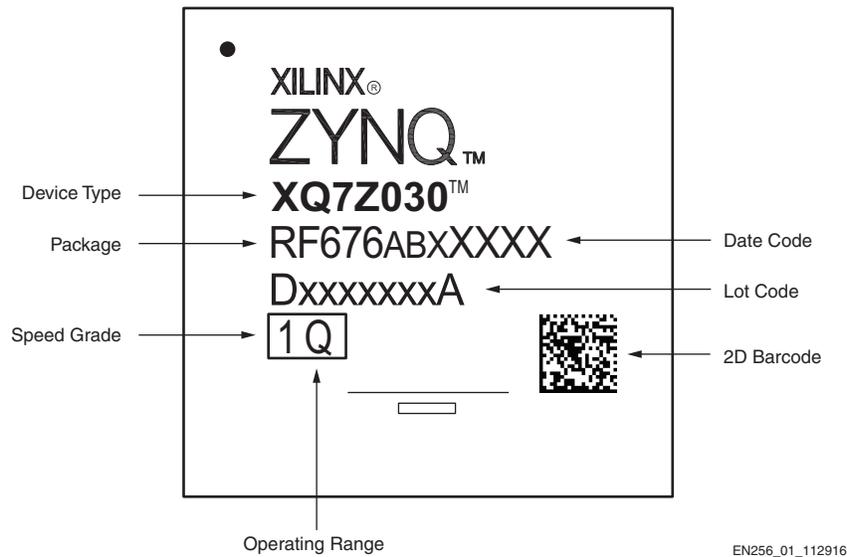
Figure 1: Example Device Top Mark

Figure 1 shows an example device top mark for the device listed in Table 1. Refer to [XCN16014](#) for details on the addition of the 2D barcode.

Date	Version	Description of Revisions
12/16/2016	1.5	Updated Figure 1 with 2D barcode.
10/19/2015	1.4	Added Under Very Rare Timing Circumstances, Transition Into Streaming Mode Might Create A Data Corruption and When ECC Is Enabled, The CHE_CORR_ECC_ADDR_REG_OFFSET Register Might Report An Incorrect Column Address .
07/13/2015	1.3	Added XQ7Z100 device to Table 1 .
03/16/2015	1.2	Added I2C Slave Monitor Mode Can Lock The I2C Bus and I2C Transaction Corruption In Slave Receiver Mode .
10/31/2014	1.1	Added I2C and QSPI sections. In SMC section, added: SMC Parallel (SRAM/NOR) Interface Does Not Correctly Assert CS0 For 64 MB Memories ; SMC Parallel (SRAM/NOR) Interface Address Bit 25 Is Inverted For 64 MB Memories ; and RxFIFO Not Empty Status Is Not Updated Promptly .
12/06/2013	1.0	Initial Xilinx release.
